# Manhole Inspection Summary

Manhole # S25I\_\_014MH

Insp Date: **4/1/09 2:16 PM**

**Location** Address: **1017 Mt Clare**

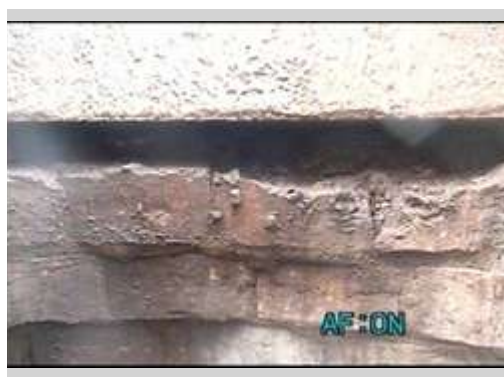
Defect 3

Condition: ☐ Sound ☐ Cracked ☐ Root Intrusion ☐ Loose Brick ☒ **Deteriorated**

Infiltration: ☐ None ☒ **Joint** ☐ Cracks ☒ **Mortar** ☐ Roots ☐ Wall

chimney deteriorated; infiltration at chimney / frame joint; missing mortar

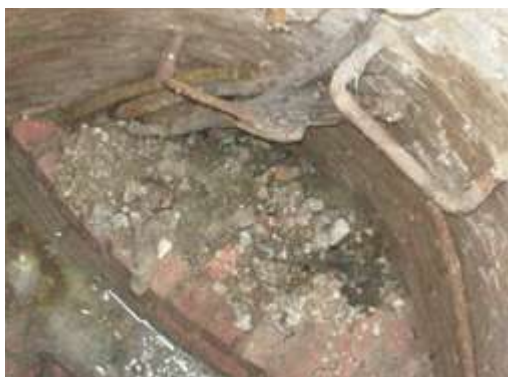
Defect 4

**Steps** Count: **7** Missing: **4** ☒ **Corroded**

missing/corroded steps

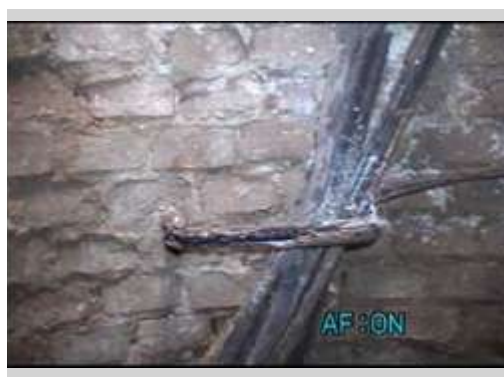
Defect 2

corroded rung

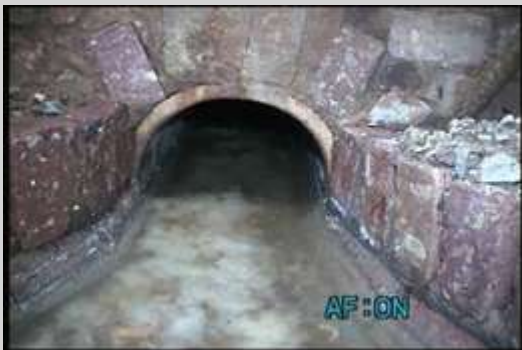
12 O'Clock Outflow

8 in. Circular Gravity Sewer  
Pipe Out @ 12 O'Clock

Pipe Height: **7.2** (in.) Rod and Bar (Angled)  
Pipe Material: **Clay** ☐ Pipe Lined  
Invert Depth: **7.48** (ft.) Flow Characteristics: **Slow**  
Deposits: ☒ None ☐ Mud ☐ Sludge ☐ Debris ☐ Grease  
Silt Depth: **0** (in.) Deposits Extent:  
Infiltration: **None** Pipe Seal Cond: **Sound**

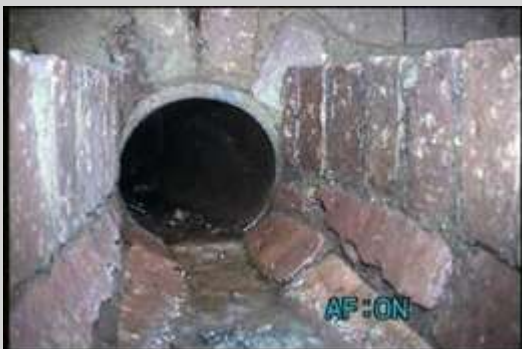
5 O'Clock Inflow

6 in. Circular Gravity Sewer  
Pipe In @ 5 O'Clock

Pipe Height: **6** (in.) Rod and Bar (Angled)  
Pipe Material: **Clay** ☐ Pipe Lined  
Invert Depth: **7.32** (ft.) Flow Characteristics: **Slow**  
Deposits: ☒ None ☐ Mud ☐ Sludge ☐ Debris ☐ Grease  
Silt Depth: **0** (in.) Deposits Extent:  
Infiltration: **None** Pipe Seal Cond: **Sound**

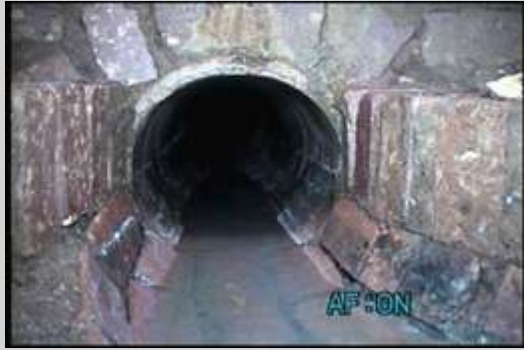
9 O'Clock Inflow

8 in. Circular Gravity Sewer

Pipe In @ 9 O'Clock

Pipe Height: **8.4** (in.) Rod and Bar (Angled)

Infiltration: **None** Pipe Seal Cond: **Sound**
